REPORT ON
STRUCTURAL SAFETY & STABILITY EVALUATION OF
SRISTI GLOBAL SCHOOL
(SRISTI EDUCATION TRUST)
Sy. No.22/1, Kaveri Layout, Kodigehalli Village, KR Puram
Hobli, Bengaluru, Karnataka-560067

Investigation done by: NISHICON INFRASTRUCTURES
Non-Destructive Testing and Structural Rehabilitation
Engineering Council of India Certified, Reg: PE/00560/16/R21
#317/19, 1st G Cross, Subbanna Garden, R.P.C Layout (west) Extn,
Vijayanagara, Bengaluru, Karnataka -560040

April
2022

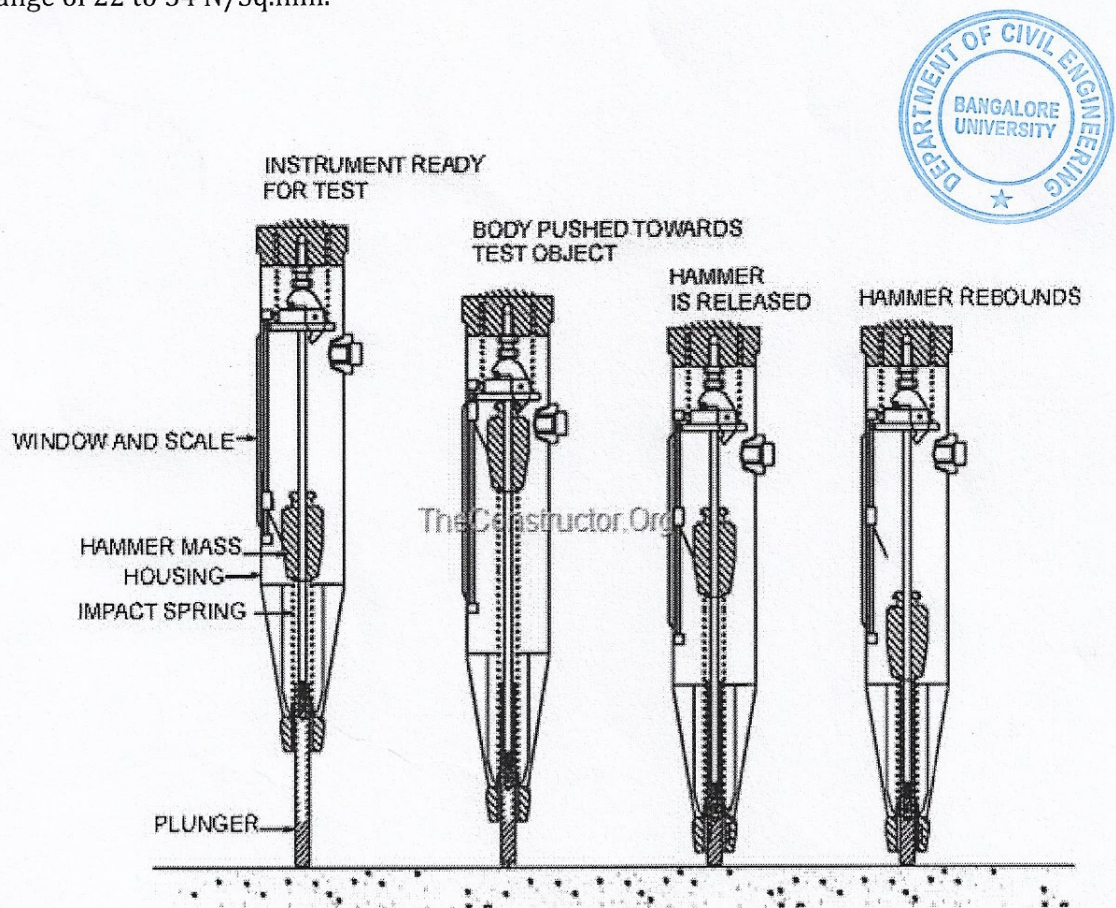
Fig. No 1 Working of rebound hammer

Rebound Hammer Test is a quick method for assessing the surface hardness / in-situ strength of concrete based on the surface hardness indicated by the rebound number. If the strength of concrete is high, then the rebound number is also high.

Rebound Hammer Test was carried out on various RC members viz top roof slab and available beams at random to assess the surface hardness / in-situ strength of concrete. The above test was conducted using SCHMIDT Rebound Hammer (N-Type) from M/s. **Proceq**, Switzerland as per the guidelines in Indian Standard IS: 13311 (Part-II).

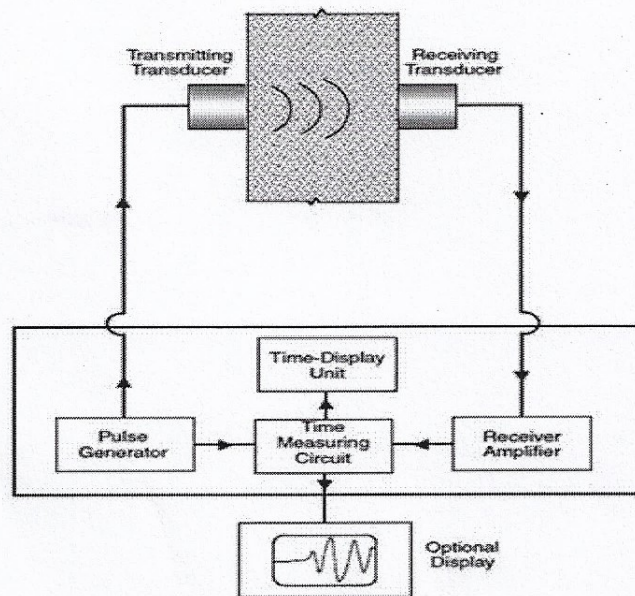
Fig. No 2 Working of Pundit

Ultrasonic Pulse Velocity test (UPVT) is being extensively used to assess the quality /uniformity and integrity of concrete. This test is generally used for measurement of concrete uniformity, estimation of crack depth, presence of honeycombs voids, assessment of concrete deterioration and assessment of in-situ strength (for lower grade concrete only). Ultrasonic Pulse Velocity Test was carried out on various RC members viz top roof slab and available beams at random to assess the conformity of concrete as per standard practice. The above test was conducted using "PUNDIT Lab+" (Portable Ultrasonic Non-Destructive Digital Indicating Tester) equipment with appropriate transducers from M/s. Proceq, Switzerland as per the guidelines in Indian Standard IS: 13311 (Part-I)-1992- (Reaffirmed in 2013) and also as per standard literature. Direct and in-direct method of testing was adopted depending on the site condition.
